Technical Service Bulletin

34 Oil leak from the ATF sump area

34 19 41 2050215/5 June 13, 2019. Supersedes Technical Service Bulletin Group 34 number 19-40 dated April 2, 2019 for reasons listed below.

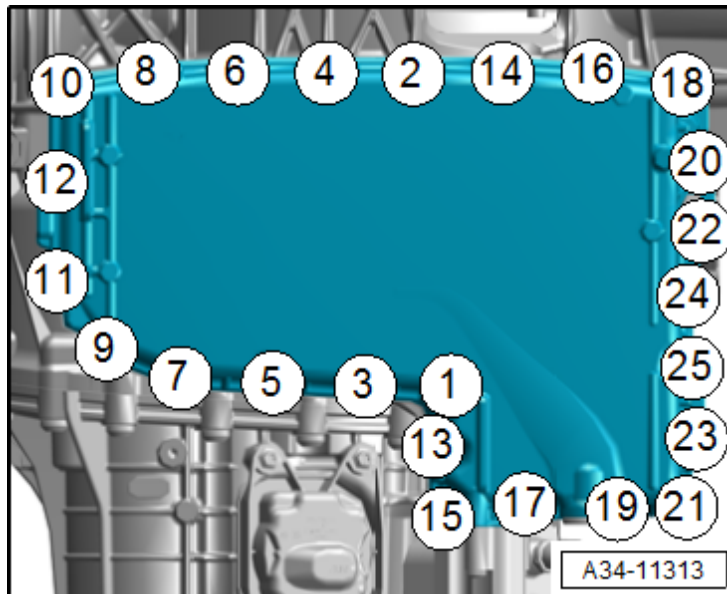
Figure 1. Tightening sequence.

1. Take photos of the actual condition and attach to the Repair Order.
2. Retighten the ATF sump bolts with a torque of 5 Nm. Make sure to follow the correct tightening sequence (Figure 1).

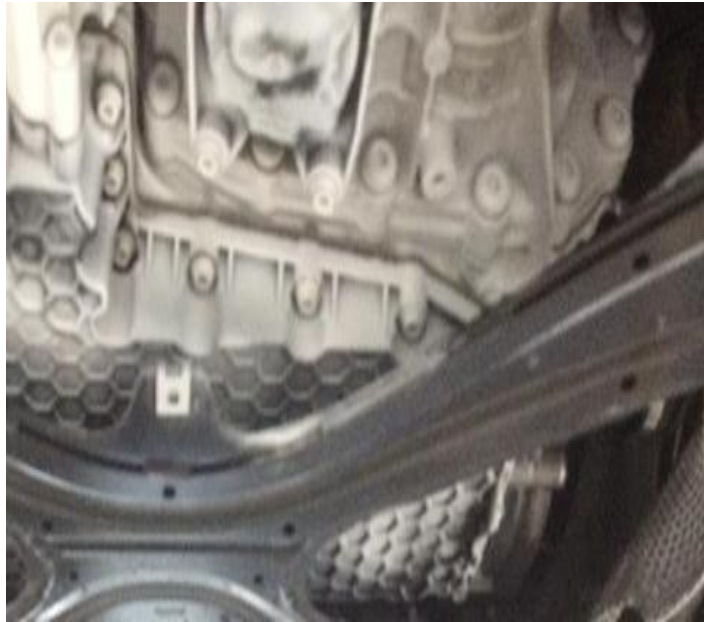
Figure 2: Transmission with oil leak detection spray applied.

4. Apply oil leak detection spray (Part # G 001 900 A1 or a locally available talcum-based oil leak detection spray equivalent) to the sealing area of the sump, ATF cooler, drain plug, and the case half seam (Figure 2).

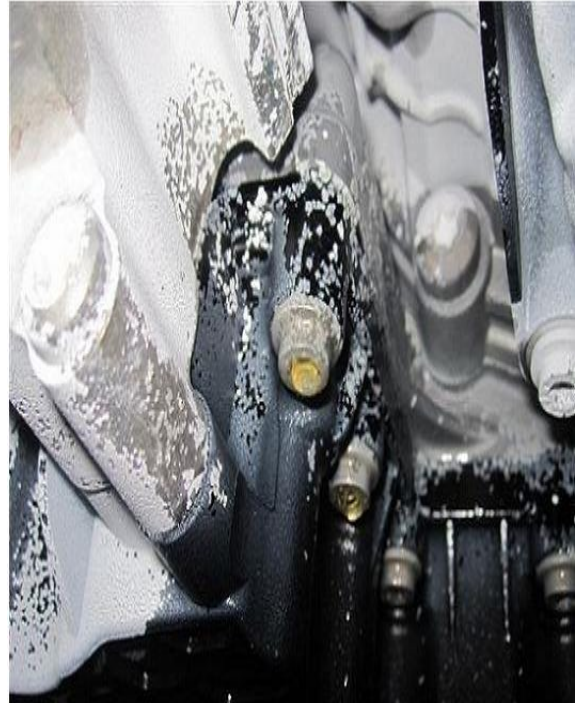
Tip: If there are drips after the test drive as shown (Figure 3) you should be able to determine if the leak is from the ATF sump gasket or if the leak is from elsewhere. Make sure to check for leaks above the sump gasket. Check the seam of the transmission case split and the weep hole of the double seal (Figure 4). Both of these leaks can be confused for an ATF sump gasket leak.

Figure 3. Oil leak.

Tip: If the ATF sump gasket has been diagnosed to be leaking after all the above checks, replace the ATF sump gasket according to the Repair Manual and recheck for leaks. Use Warranty Table 2 if the ATF sump gasket is replaced. If the repair manual is followed using the special tools, the required wheel alignment should not be necessary.

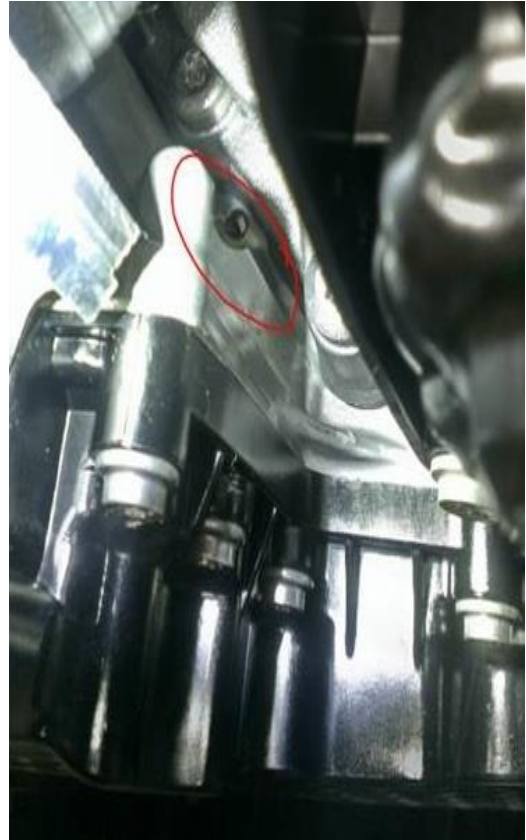
Figure 4. Double seal weep hole location.

If the oil leak is not from the ATF sump gasket please open an Audi Technical Assistance contact with the pictures of the leak attached to the ticket and contact Audi Technical Assistance for repair authorization.
