# Technical Service Bulletin

## 34 Oil leak at the transmission connector

34 20 47 2058875/1 March 24, 2020.

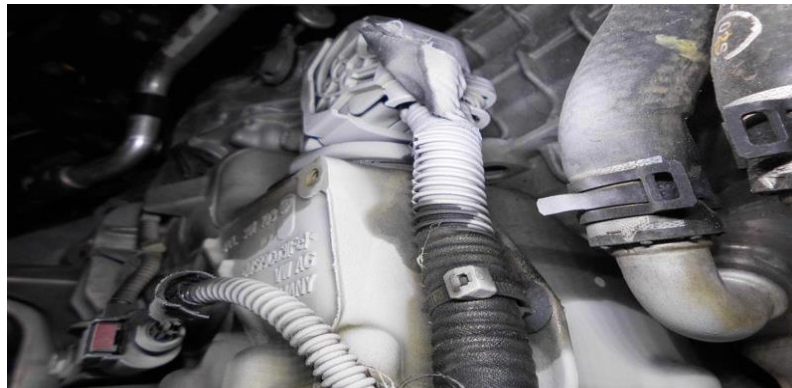
- There is oil leaking from the transmission control module seal (Figure 1).

*Figure 1. Evidence of oil leak from the transmission control module seal.*

1. Residual oil from the manufacturing of the transmission (lubrication of seal when installing the control module in transmission housing).
2. Overlap of seal on the transmission control module connector is not sufficient in all tolerances.

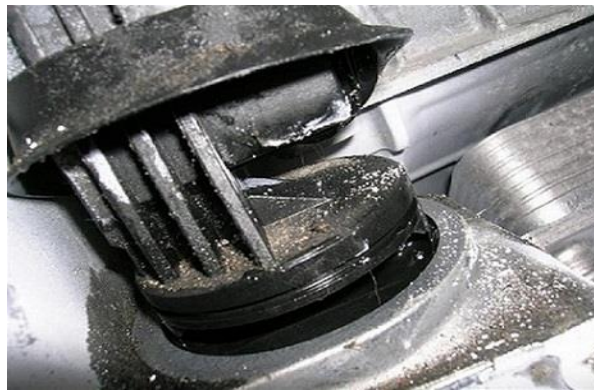
**Figure 2.** Dust cover lifted to view the sealing area.

1. If the oil leak is confirmed to be from the area of the transmission control module seal proceed as follows:
  - Unplug the transmission control module connector and lift the dust cover below the connector to view the sealing area cavity (Figure 2).

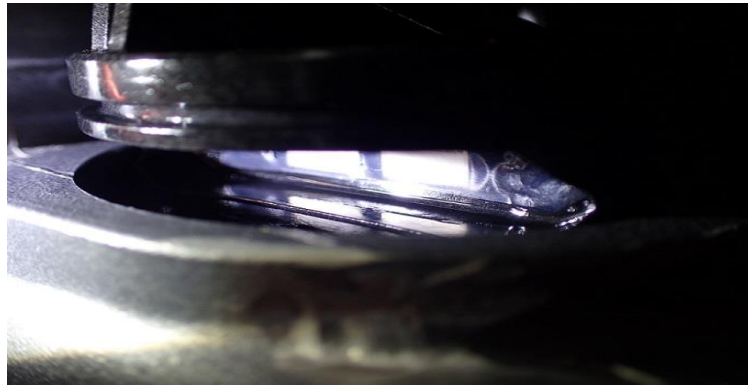
**Figure 3.** A thin film of oil in the cavity.

3. Repair/Diagnosis steps for a thin film of oil in the cavity:
  - *Very thoroughly clean the area* and spray the affected area with oil leak detection spray (Part # G 001 900 A1 or a locally available talcum based oil leak detection spray equivalent).

- Perform an extensive test drive and assess the oil in the cavity again.
  - If there is no more oil accumulation, it is not necessary to fit a new seal. No further repair is required and the repair is complete. The film of oil was most likely from the assembly of the transmission.

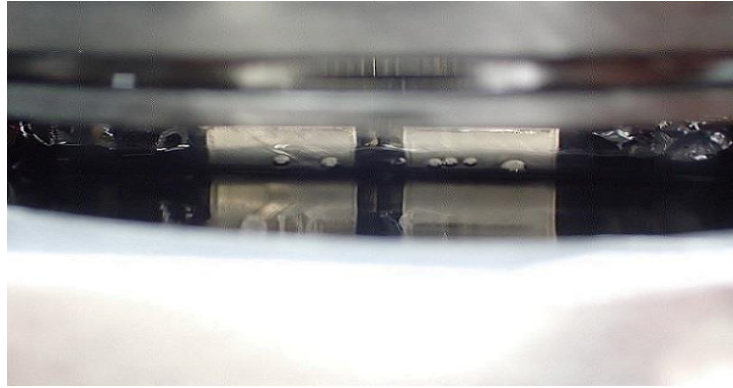
**Figure 4.** A puddle of oil in the cavity.

- If there is oil moisture visible again continue to Step 4.
4. Repair steps for oil leaking from the transmission control unit seal:
  - Save pictures of the oil leak with the Repair Order for warranty purposes.

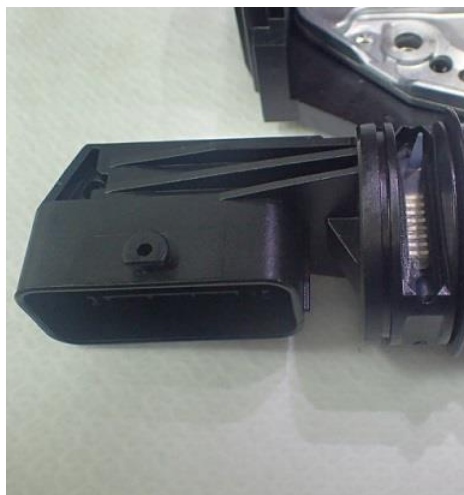
**Figure 5.** Option for 2<sup>nd</sup> seal.

- When the transmission was manufactured, a single seal was installed on the transmission control unit but there is an option for a second lower seal (Figure 5). To repair the oil leak we will replace the original seal and add a second seal in the lower position (Figure 6).

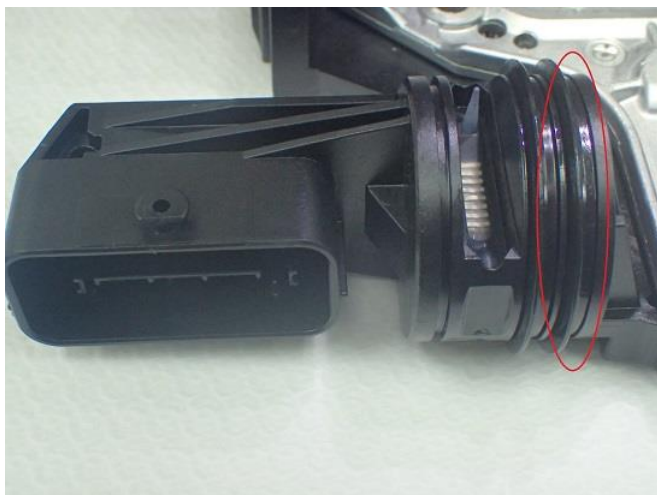
**Figure 6.** Lower seal installed.

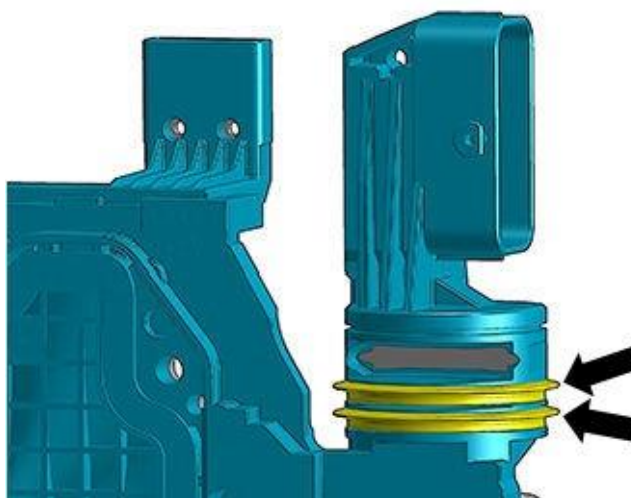
**Figure 7.** Seal installation.

- Remove the mechatronics unit per the repair manual.
- Remove the original seal from the transmission control module.
- Install two new seals with the sealing lip on the side of the electrical connection (Figure 7).
- Reinstall the mechatronics unit per the repair manual.
- Clear any faults that may have been set during the repair.
- Test drive and confirm the leak is repaired.
