Technical Service Bulletin

80 Temperature different between front driver and passenger sides

80 08 05 2013883/5 December 5, 2008. Supersedes Technical Service Bulletin Group 80 number 08-03 dated June 25, 2008 for reasons listed below.

Model(s)	Year	VIN Range	Vehicle-Specific Equipment
A6	2005 – 2007	All	Not Applicable
A6	2008	000001 – 097314

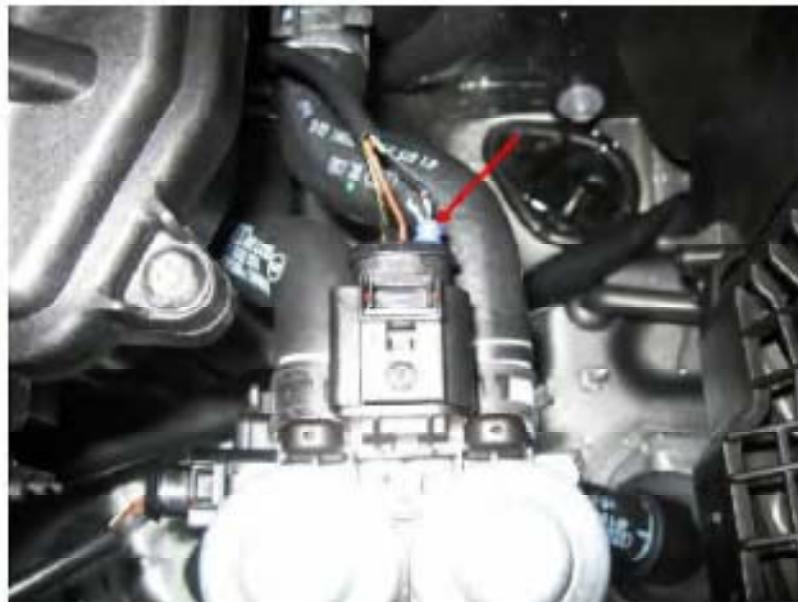
Figure 1. A pressed-out pin.

2. Check the electrical connector on the pump valve unit in the plenum chamber (Figure 1). Seat the plug correctly, or repair the pin with the repair case VAS 1978A.
