### Technical product information

Transaction No.: **2016428/3**

Noises from driver storage compartment in dashboard - A8

Release date: 08-Jan-2010

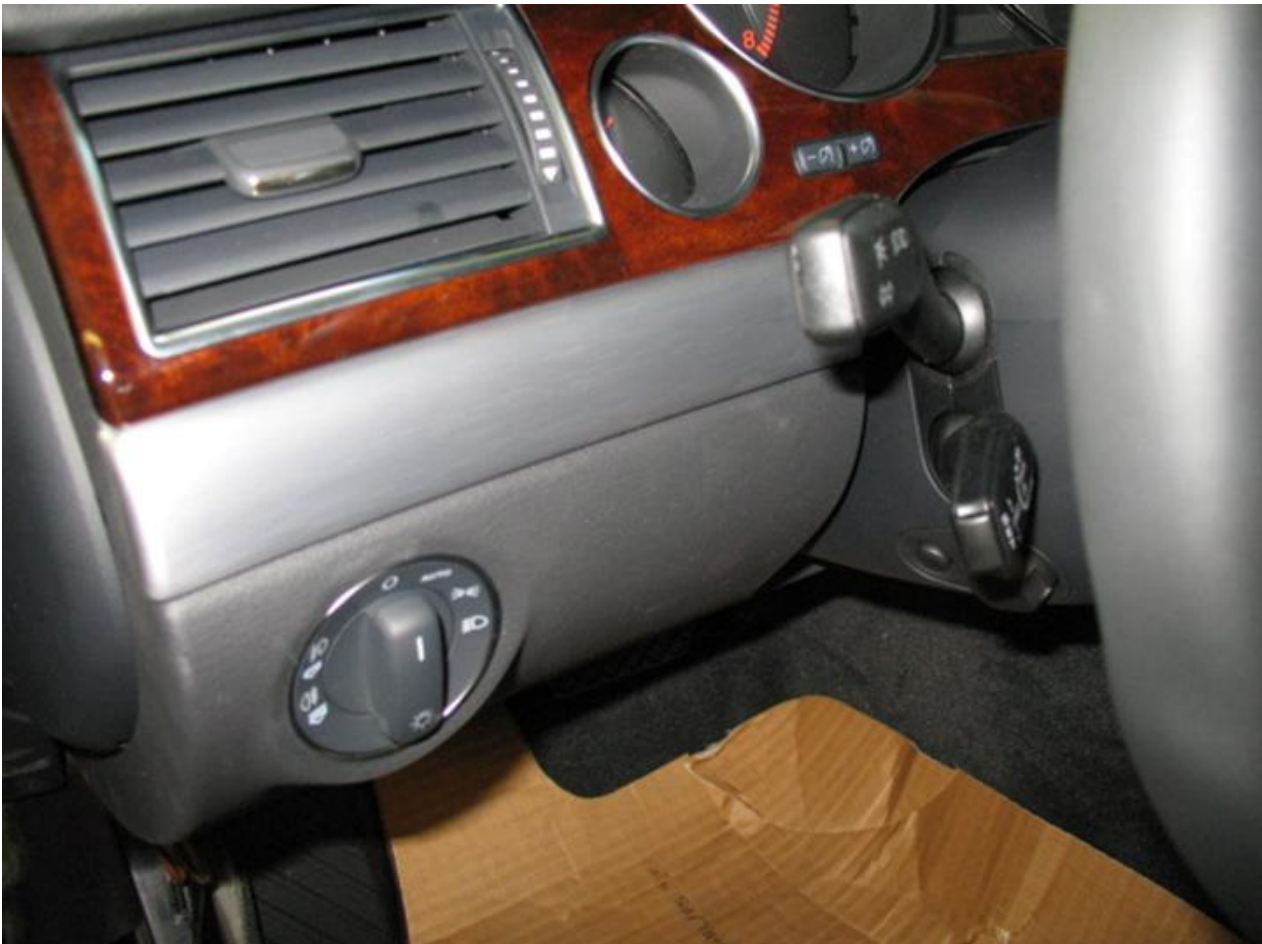
Illustration 1 shows the affected component.

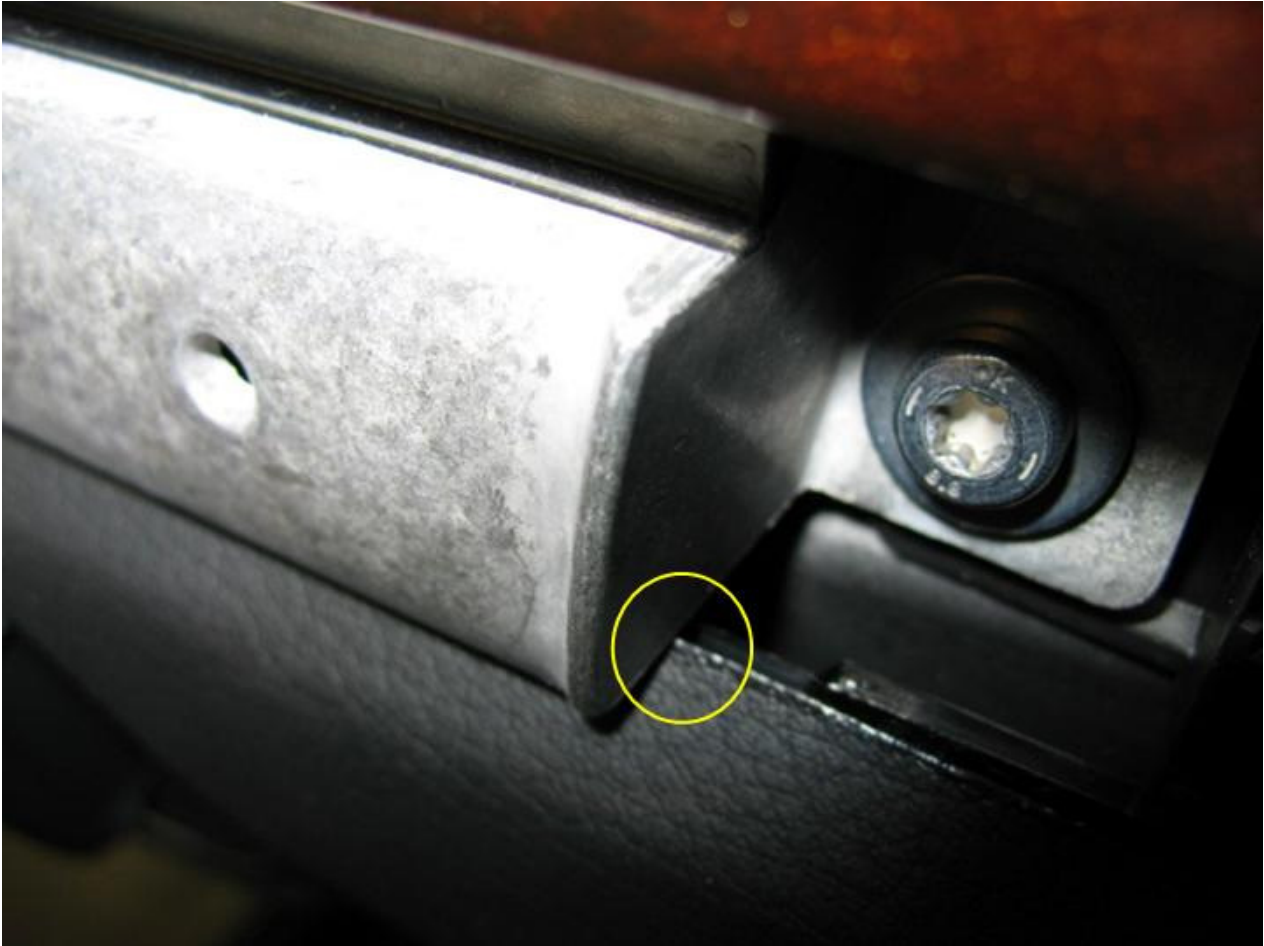
The storage box touches the dash insert trim.

Illustration 2 shows the point (see yellow circle) where the storage box touches the dash insert trim.

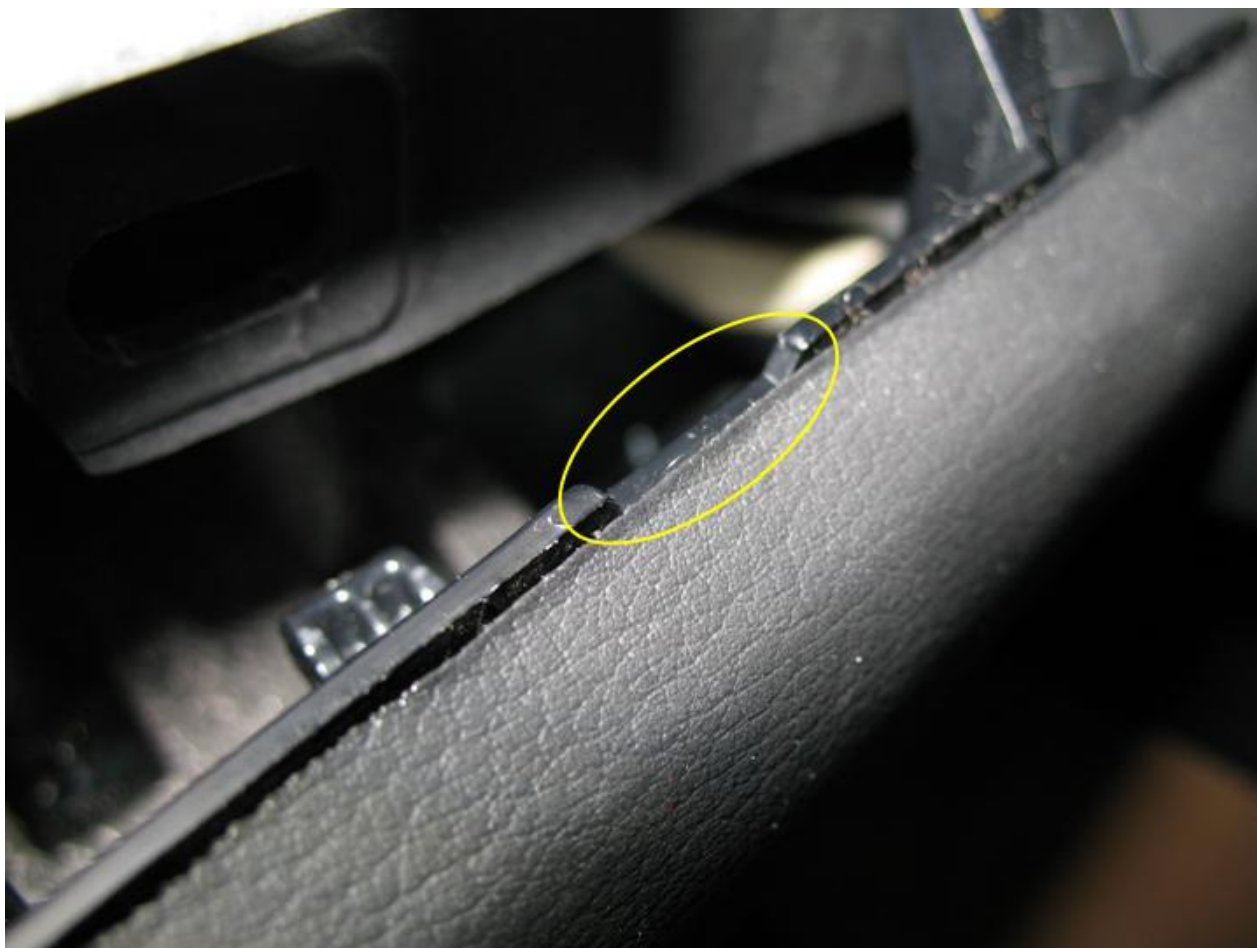
Illustration 3 shows the area of the cut-out section (see yellow circle).

The cut-out section should be made with a small angle grinder.
