# Replacing the rear bumper cover of my 1999 Audi A6 Quattro Avant

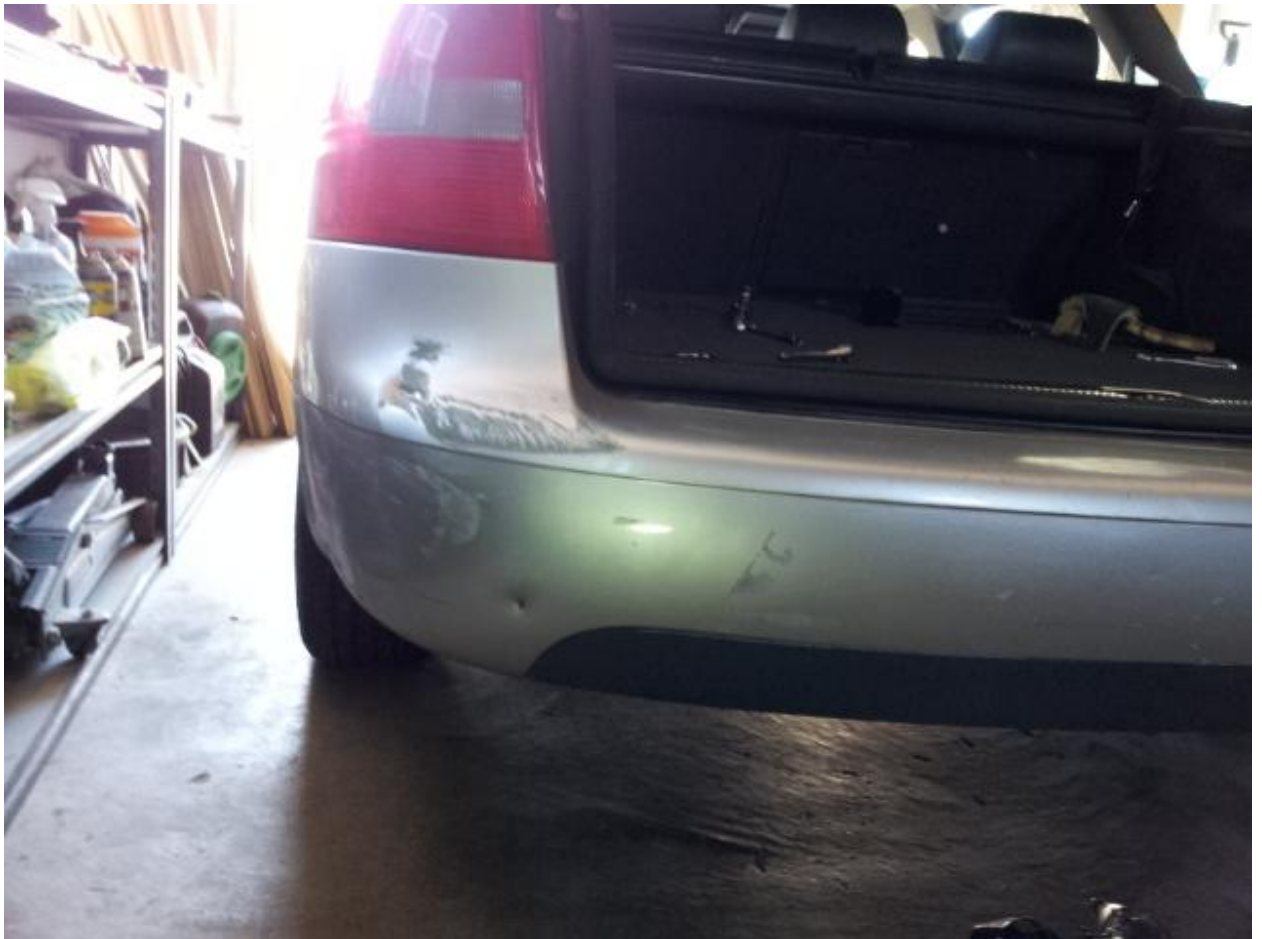
1. The infamous "before" shot:

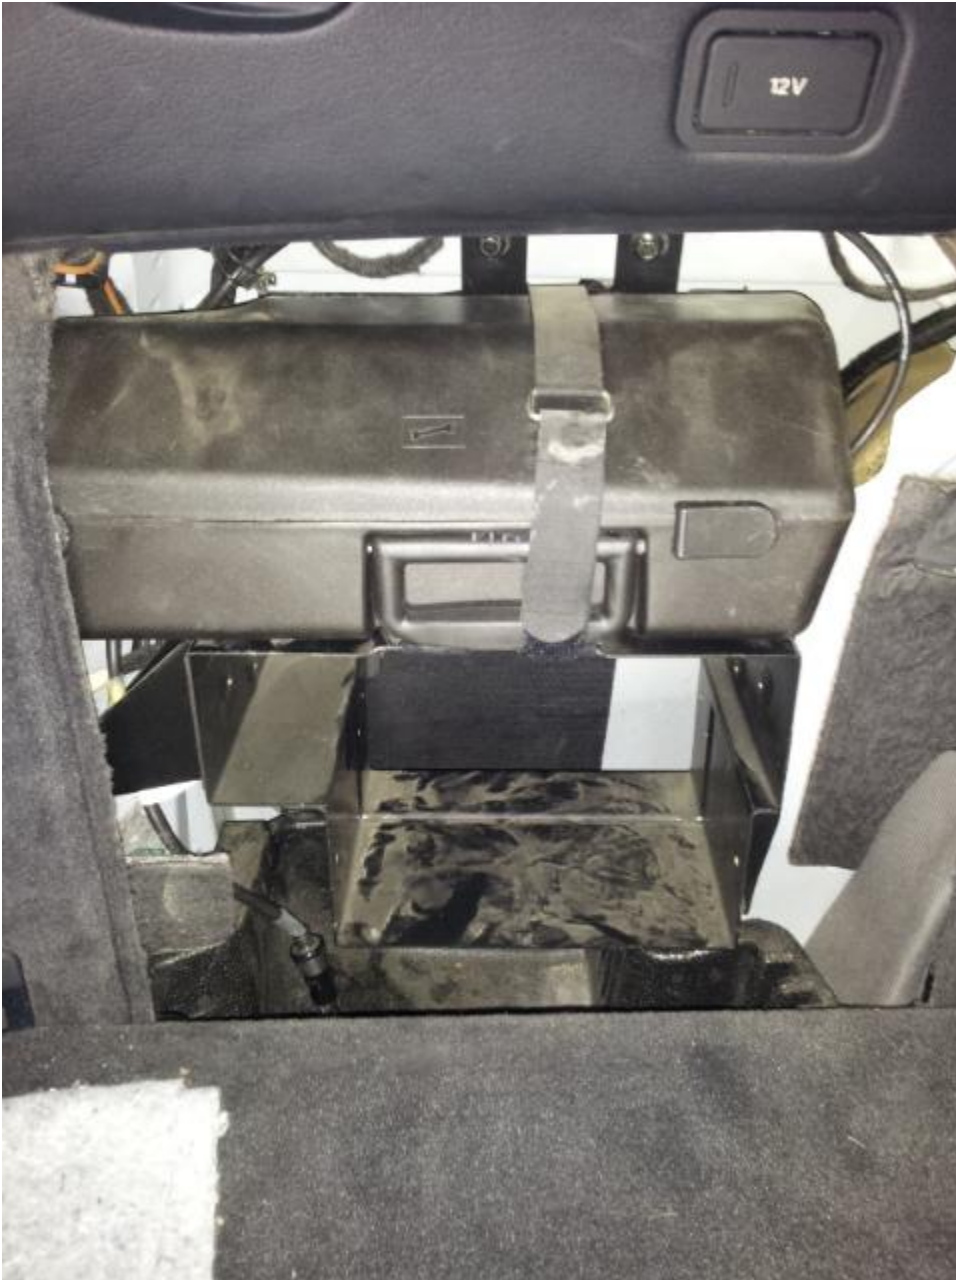
Driver side CD changer bracket. I don't have the changer so I just had to remove the bracket.

2. The Avant has the CD changer mounted behind the rear driver side wheel well and the amplifier behind the rear passenger side wheel well. In order to get to the bumper screws I had to remove the CD changer and its holding bracket on the driver side and part of the amp on the passenger side. Both were not hard to get out and it made the job a lot easier.

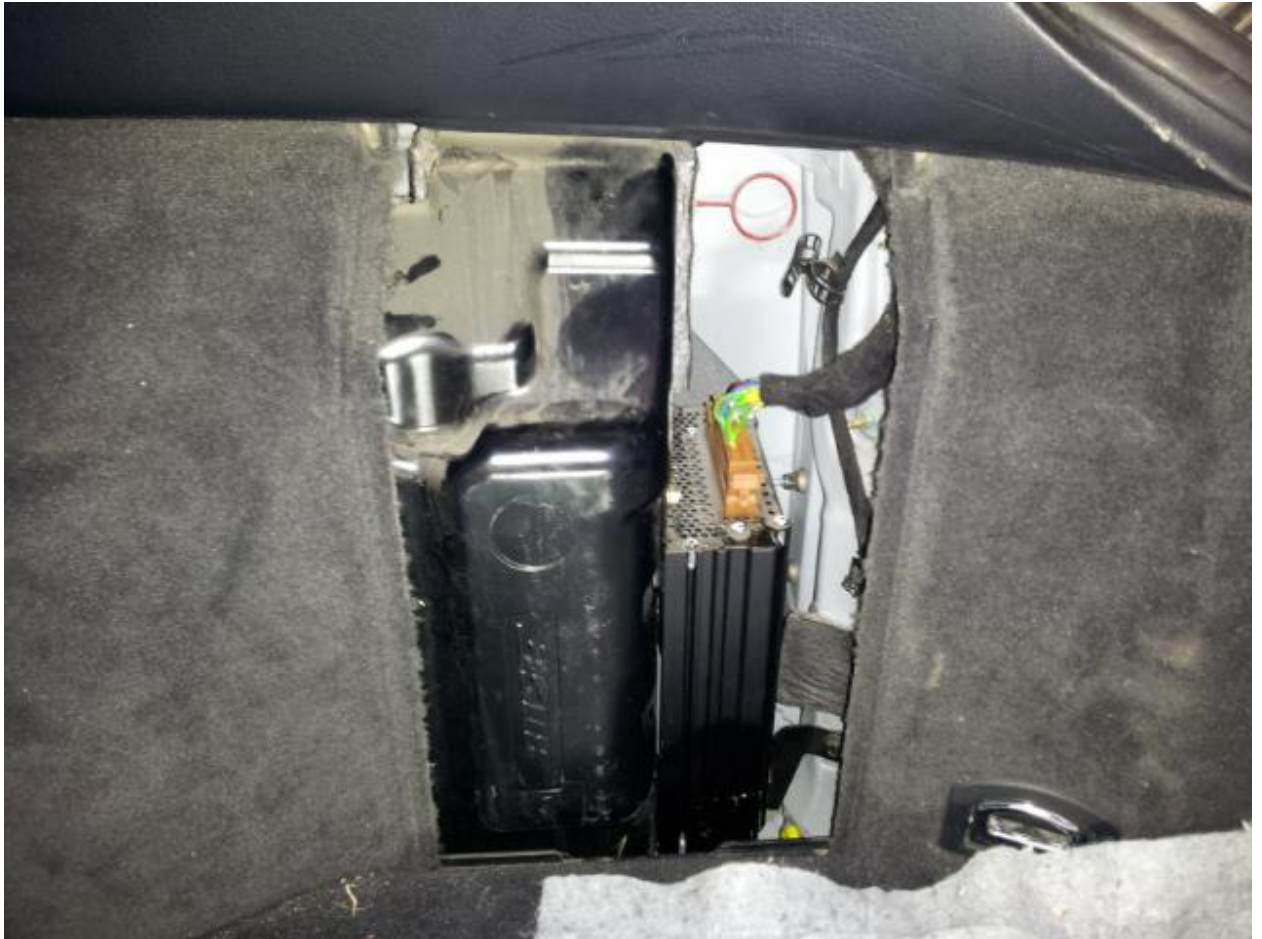
Passenger side amp. At first I thought I had to remove the whole amp, but fortunately removing the head unit was enough to get comfortably to the screws.

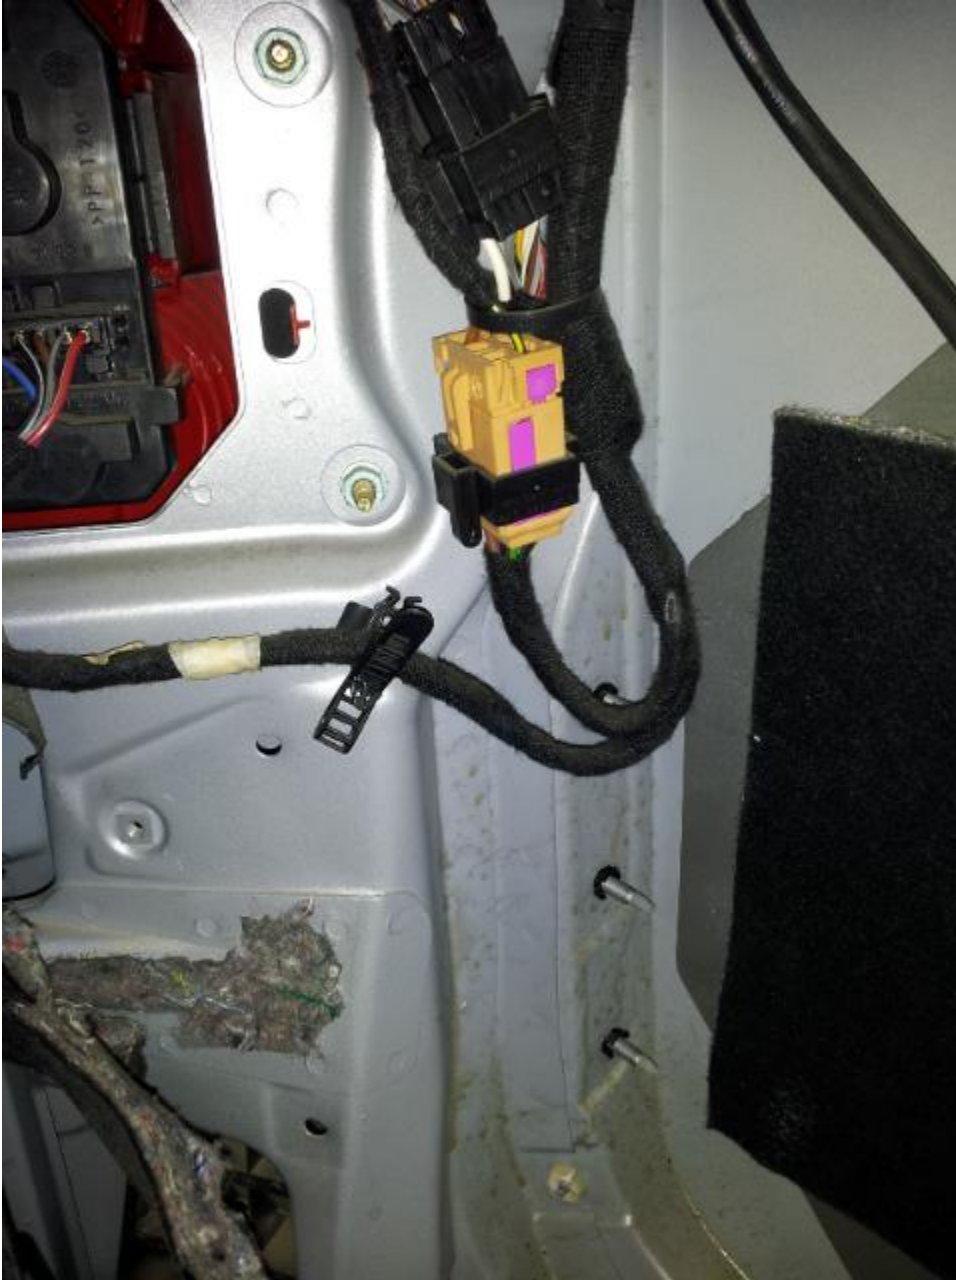
CD changer bracket completely removed, great access to the screws.

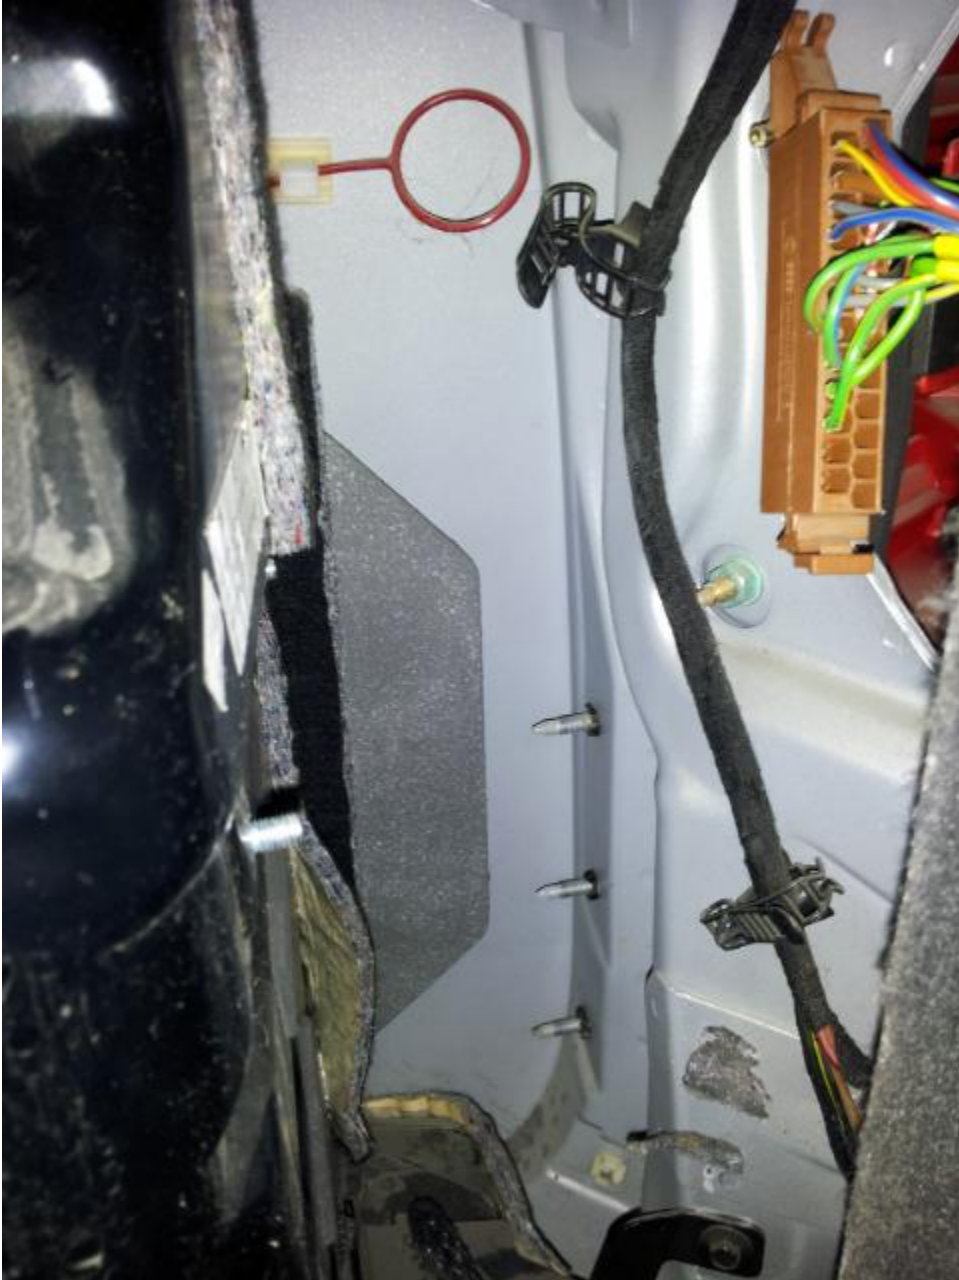
Passenger side is a little tighter but still manageable.

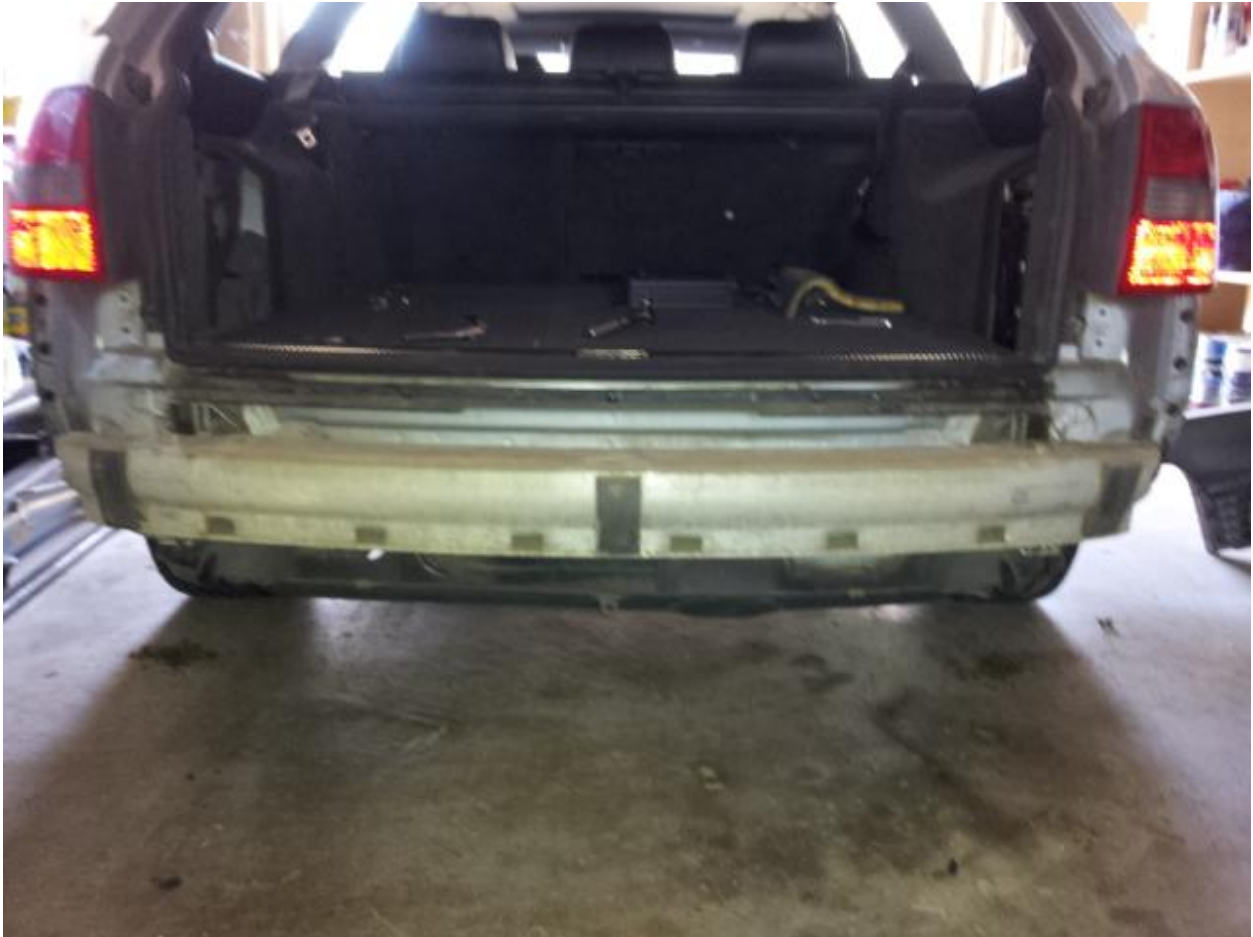
3. There are 15 screws/bolts all together holding the bumper cover on. 5 bolts on each side inside the body, 2 bolts on each side right behind the rear wheels and one screw below the bumper cover, right in front of the tow hook. Loosen all the screws and you are ready to pull off the cover. Since I wasn't going to reuse my old cover I wasn't concerned about scratches. If you are reusing the cover, lay out some moving blankets to set the cover down after it comes off. After I loosened all the bolts/screws I grabbed the bumper cover on one side of the car from down below and gently started pulling. Driver side came right out but the passenger side needed some serious pulling. But nothing broke and it all came off nicely.

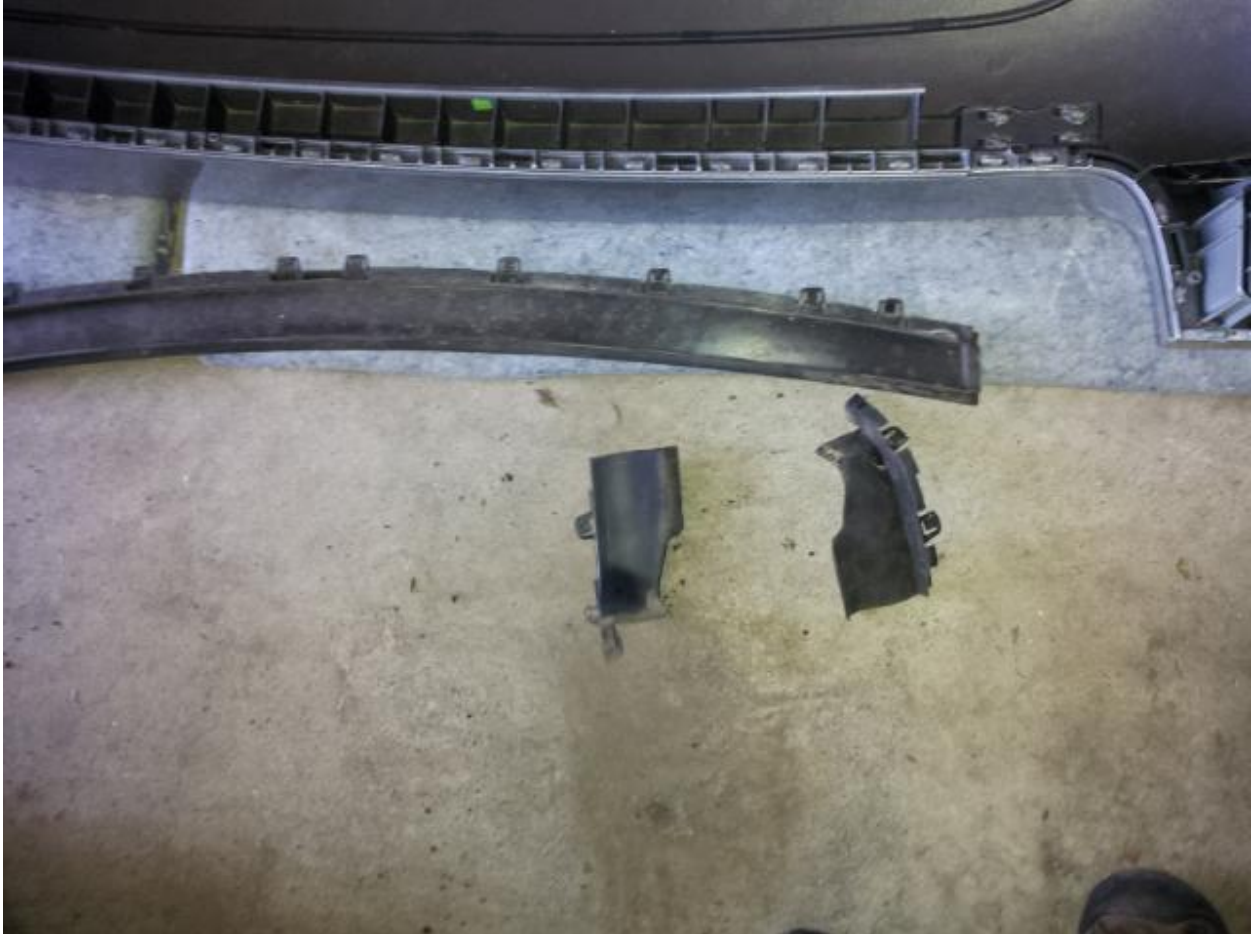
4. I did some cleaning as there was a lot of dirt and grime underneath the cover. Then I had to remove the black trim pieces from the old cover and put it on the new one. This was a little tricky as the tabs on the plastic are not easy to get off. It's not so hard on the long center piece, but the two side pieces did not budge as I could not get to the tabs at all. I ended up just janking them out and got lucky that they didn't break off. If they do I would suggest adding a screw to each one to hold them tight in place after you put them on the new cover.

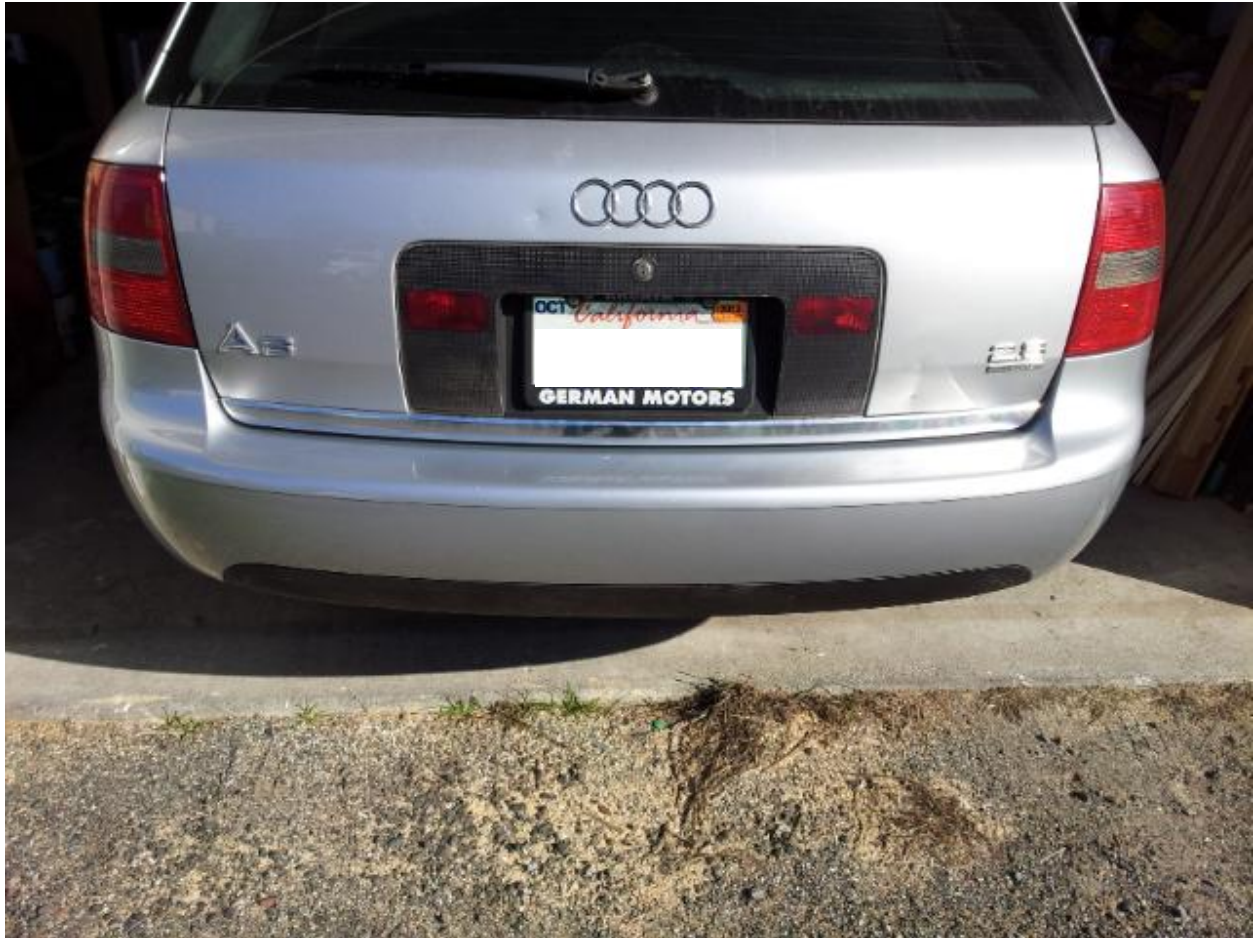
6. And finally the even more infamous “after” shot:

5. Once the trim is on you are ready to put the new cover back on. The new cover fit very nicely and I got it on very easily. Once I had it in place I put the nuts back on the 3 studs on each side of the car. The bottom part of the cover that goes forward to the tires is a little tricky as it has tabs that act as a guide. The cover didn't immediately go in and I had to slowly tighten the lower nuts until the cover was far enough forward for the guides to align. Then I tighten all the other nuts. There may be a better way, but being by myself it was the (in my opinion) safest way without being too worried about breaking anything. Take your time, you don't want to ruin any of the bolts or tabs.
