Customer pay – MMI System Update

Update procedure

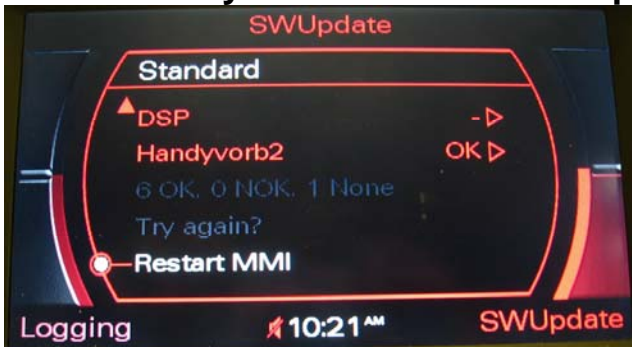
Note: The SW Update can take up to 80 minutes and usually runs automatically. However check the progress every 20 minutes.

After the Update press *Restart MMI*
