60 Noises from sunroof

Transaction No.: 2022733/2

Various noises from the sunroof.

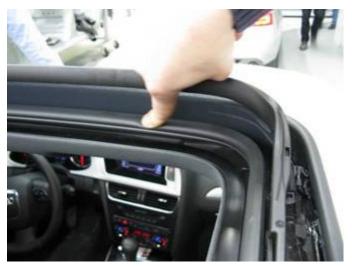
Figure 1. Seal for sunroof panel 1.

Lubricate the seals with special lubricating paste G
 052 141 A2.

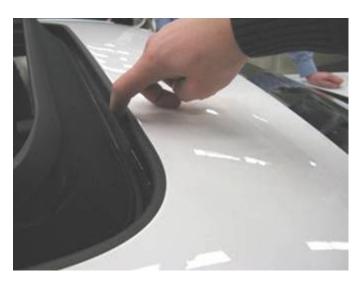
Figure 2. Outer seal.

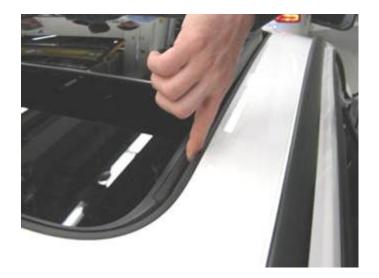
Figure 3. Seal for sunroof panel 2.

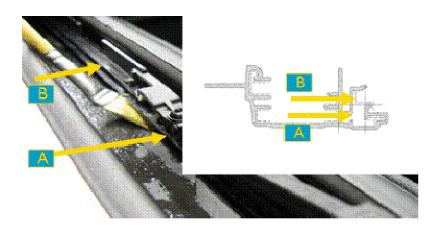
Figure 4. Inner guide rail.

Lubricate the mechanism components with lubricating paste G
 055 751 A2.

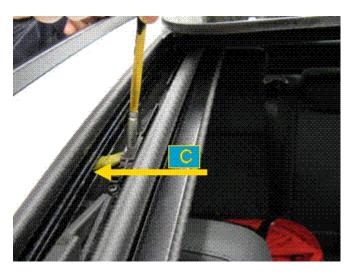
Figure 5. Lower channel of the outer guide rail.

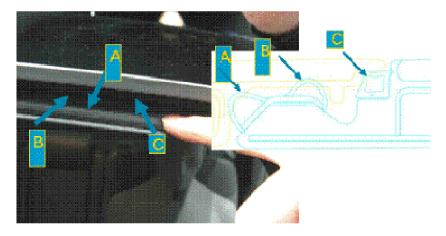
Figure 22. Audi Q7 front and rear cross seals of cover 2.

- 1. Lubricate the seals with special lubricating paste **G 052 141 A2**.
 - **Tip:** No parts have to be removed. It is only necessary to completely open the sunroof panel.
